Uniform Mitigation Verification Inspection Form

Inspection Date: 08/08/2025			
Owner Information			
Owner Name: Mark S.		Contact Person: Mark S.	
Address: 12345 Lakeland St		Home Phone: No home phone	
City: Boca Raton	Zip: 33433	Work Phone: No work phone	
County: Palm Beach		Cell Phone: 1111111111	
Insurance Company: Florida Peninsula Insurance Company		Policy #: FPH11111	
Year of Home: 1999	# of Stories: 1	Email: 123212345@yahoo.com

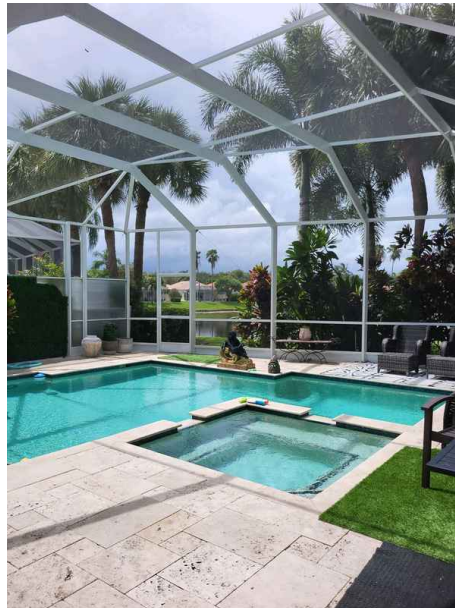
Swimming pool. Pool Area: A framed enclosure with mosquito screening has been constructed over the swimming pool.

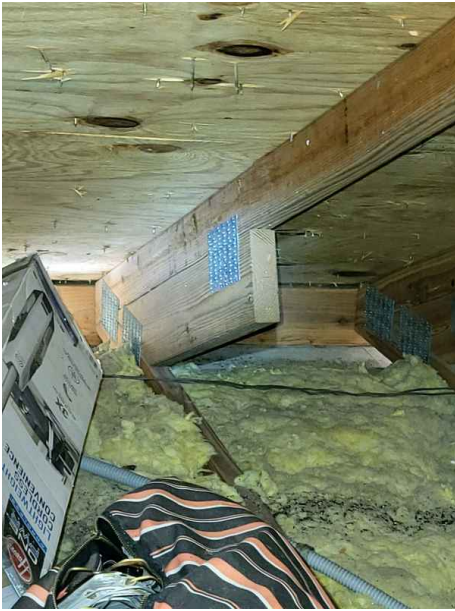
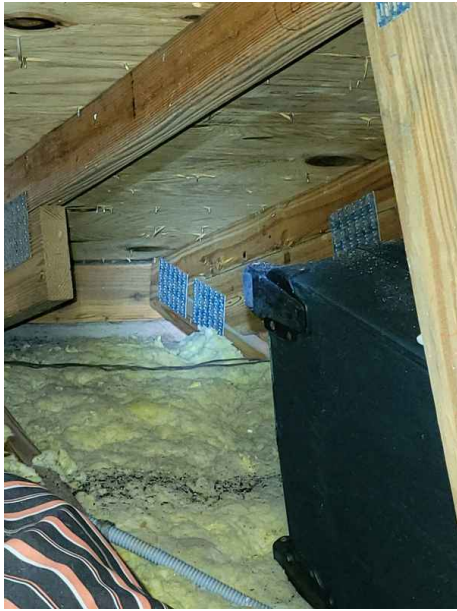
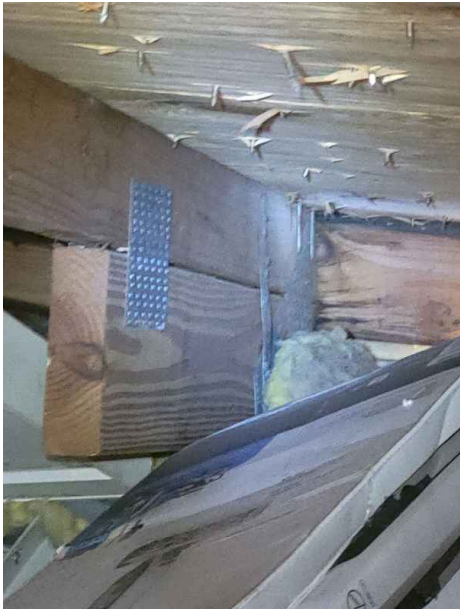
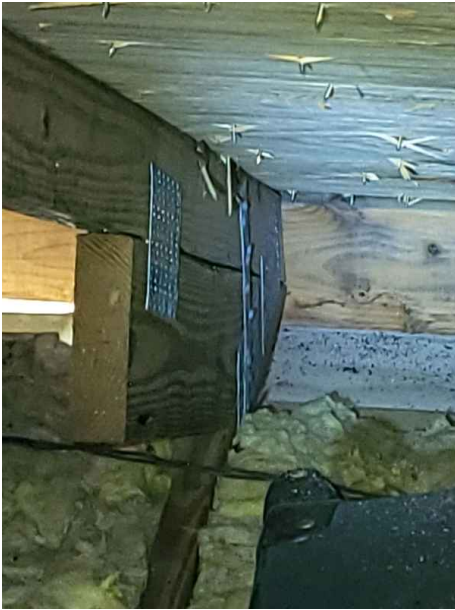
- ☐ B. Clips
 - ☒ Metal connectors that do not wrap over the top of the truss/rafter, **or**
 - ☐ Metal connectors with a minimum of 1 strap that wraps over the top of the truss/rafter and does not meet the nail position requirements of C or D, but is secured with a minimum of 3 nails.

Clips rating

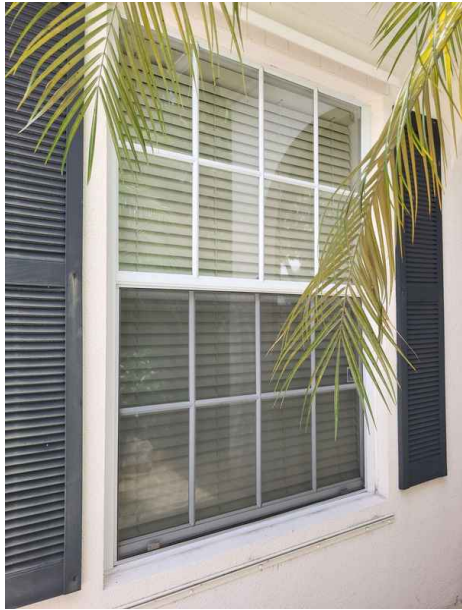
Impact rated shutters (Verified Steel panels)

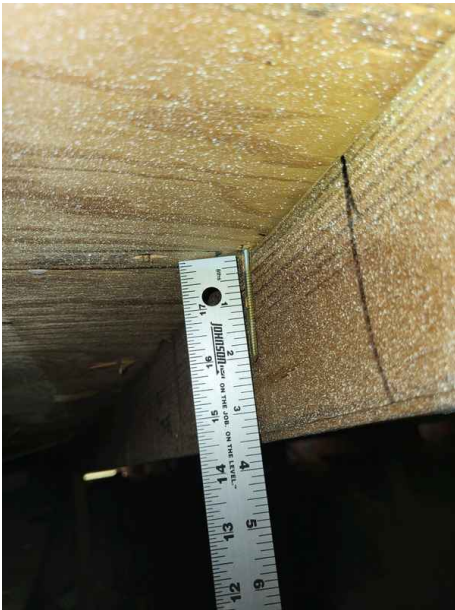
Nail d8

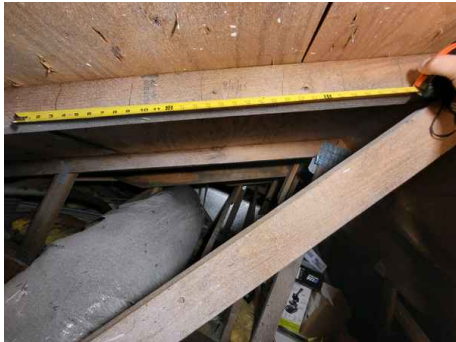
- ☒ C. Plywood/OSB roof sheathing with a minimum thickness of 7/16" inch attached to the roof truss/rafter (spaced a maximum of 24" inches o.c.) by 8d common nails spaced a maximum of 6" inches in the field. -OR- Dimensional lumber/Tongue & Groove decking with a minimum of 2 nails per board (or 1 nail per board if each board is equal to or less than 6 inches in width). -OR- Any system of screws, nails, adhesives, other deck fastening system or truss/rafter

Roof deck attachment with 8d nails spaced max of 6 inches in the field

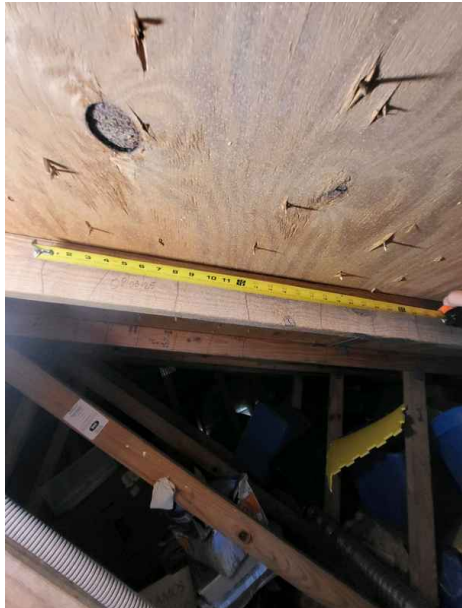
Roof deck attachment with 8d nails spaced max of 6 inches in the field

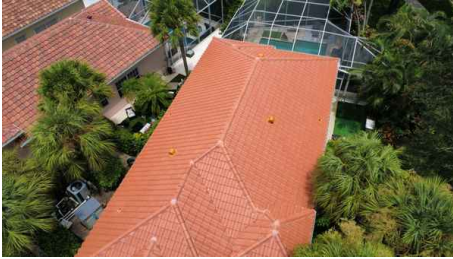
- ☒ A. Hip Roof Hip roof with no other roof shapes greater than 10% of the total roof system perimeter. Total length of non-hip features: 220 feet; Total roof system perimeter: 220 feet
- ☐ B. Flat Roof Roof on a building with 5 or more units where at least 90% of the main roof area has a roof slope of less than 2:12. Roof area with slope less than 2:12 _____ sq ft; Total roof area _____ sq ft
- ☐ C. Other Roof Any roof that does not qualify as either (A) or (B) above.

Roof shape

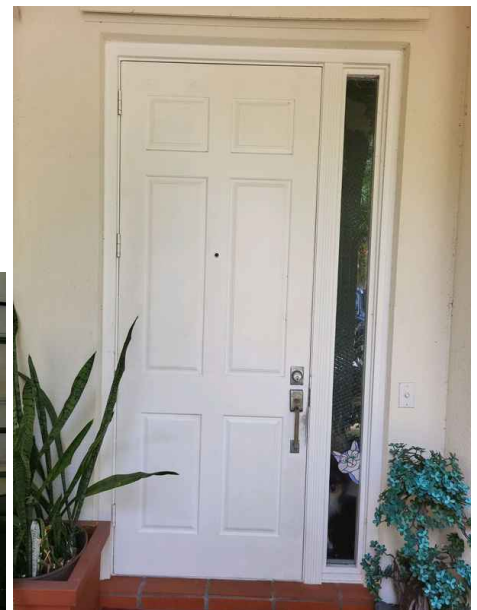
Entry door. Impact rated shutters (Verified steel panel)

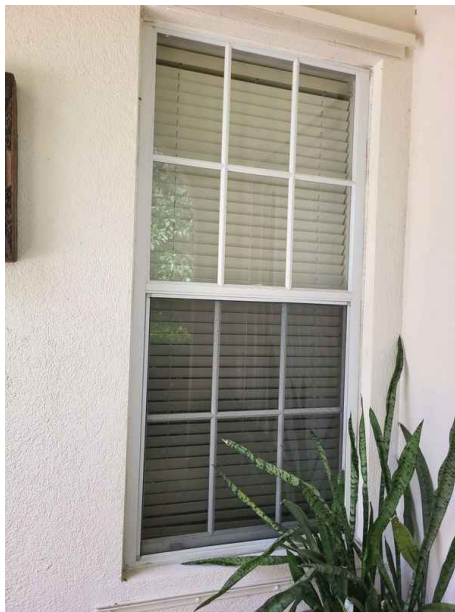
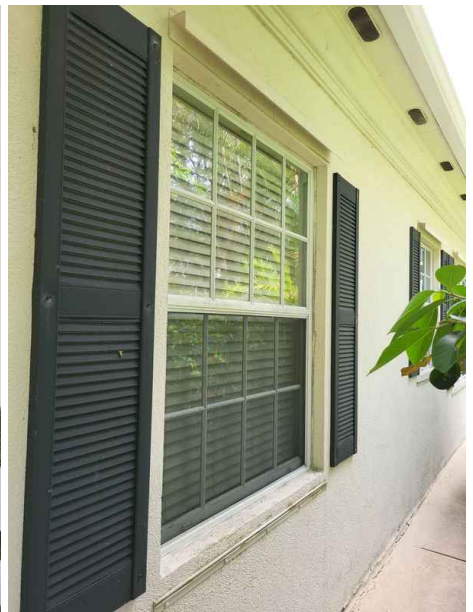
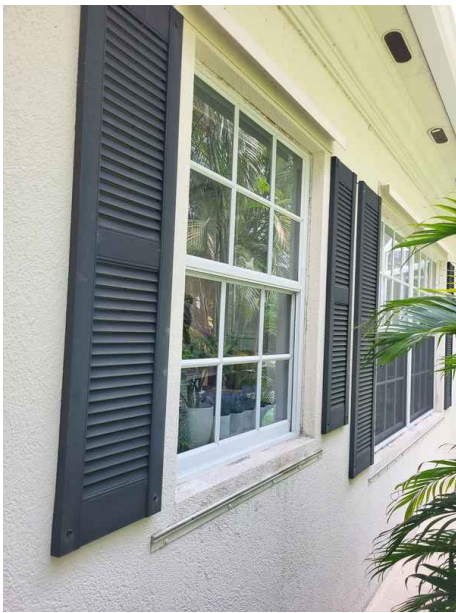
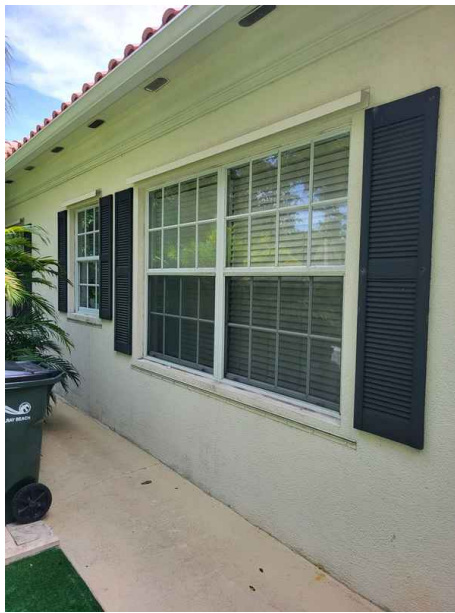
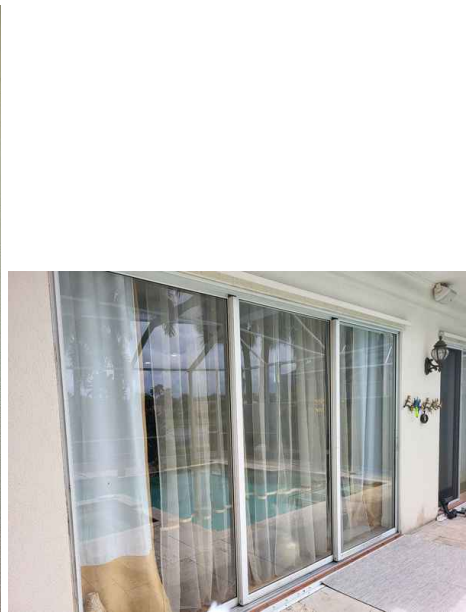
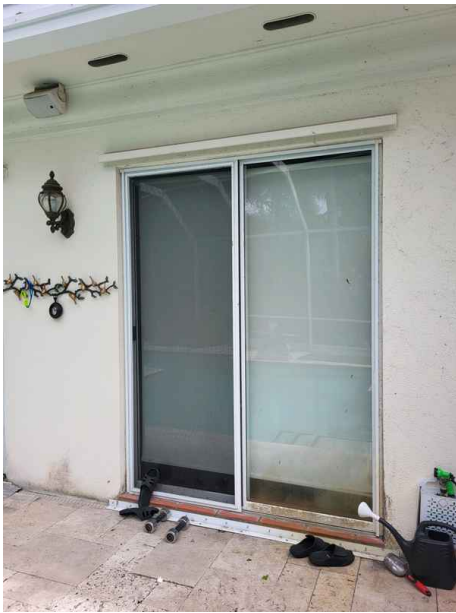
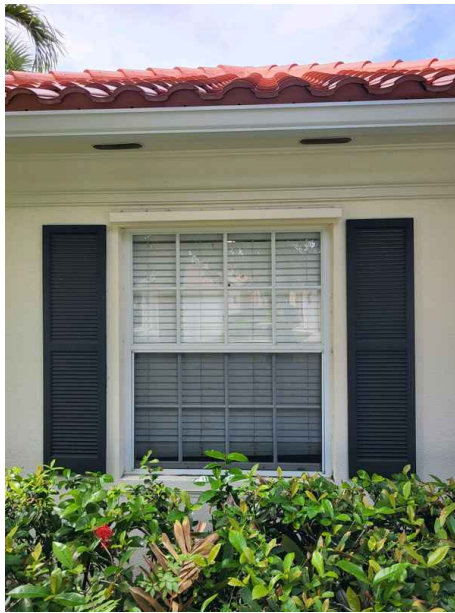
Impact rated shutters (Verified Steel panels)

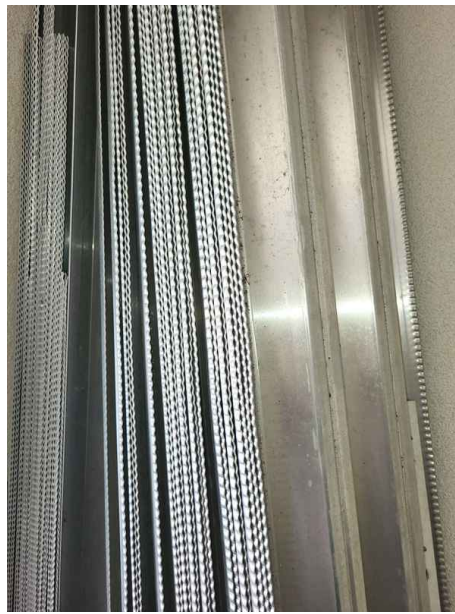
Impact rated metal shutters

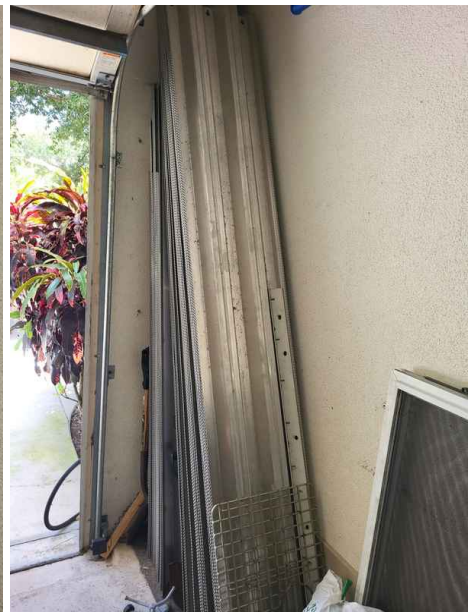
Impact rated metal shutters 2
